THAMES RIVER BASIN
NORWICH, CONNECTICUT

TAFTVILLE RESERVOIR NO. 2 DAM
CT. 00201

PHASE I INSPECTION REPORT
NATIONAL DAM INSPECTION PROGRAM

JANUARY 1979

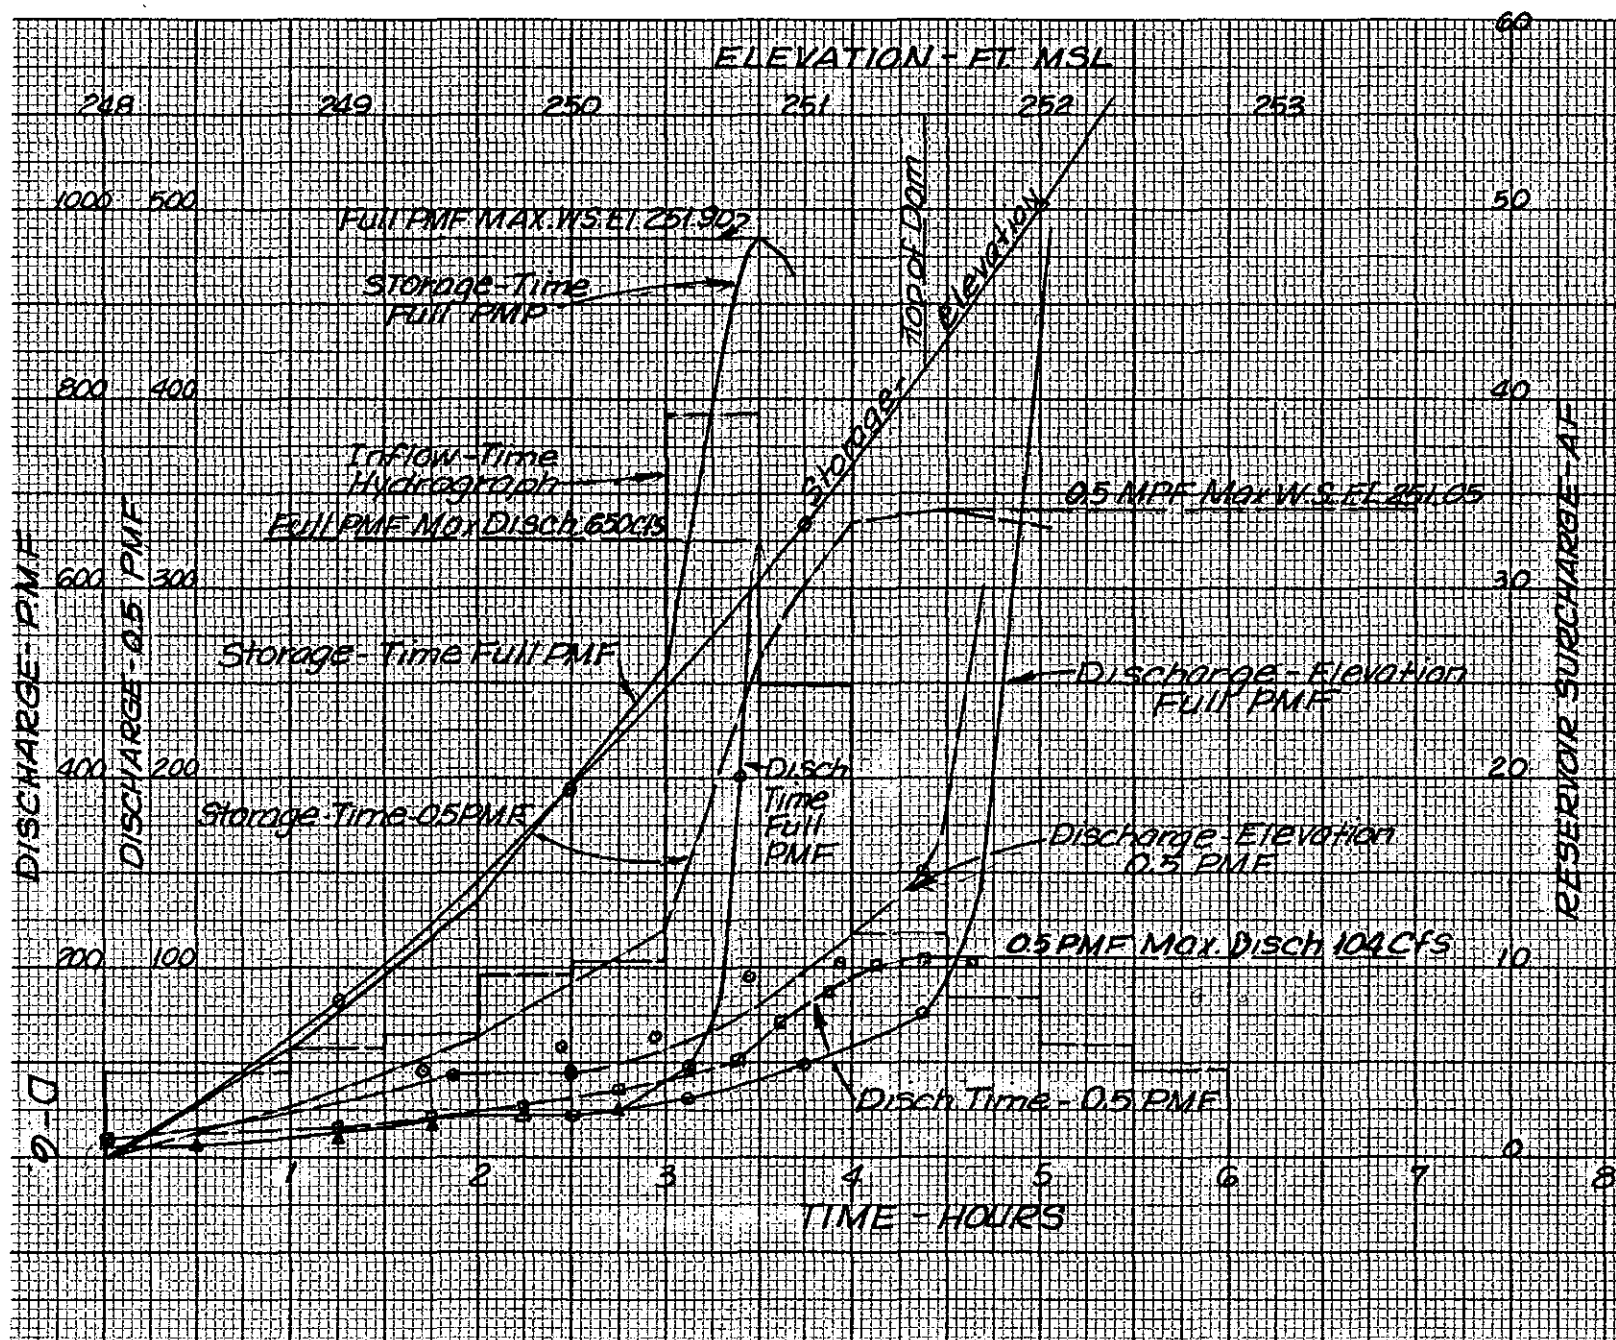
FIG. 1-SHT D-6

Because of the small drainage area with steep slopes and short water courses, no lag time was assumed and instantaneous runoff was taken from direct precipitation on the area. Tabulated values are given on Sheet D-5. The resulting hydrograph for a full PMF is shown on Figure 1, Sheet D-6, Appendix D.

On Figures 1 and 2, Sheet D-6 and D-7 in Appendix D, the flood routings are shown in graphical form.

TABLE RESERVOIR NO. 2
FLOOD ROUTING FOR FULL PMF AND 0.5 PMF
RESERVOIR TO NORMAL STORAGE LEVEL AT
START OF FLOOD

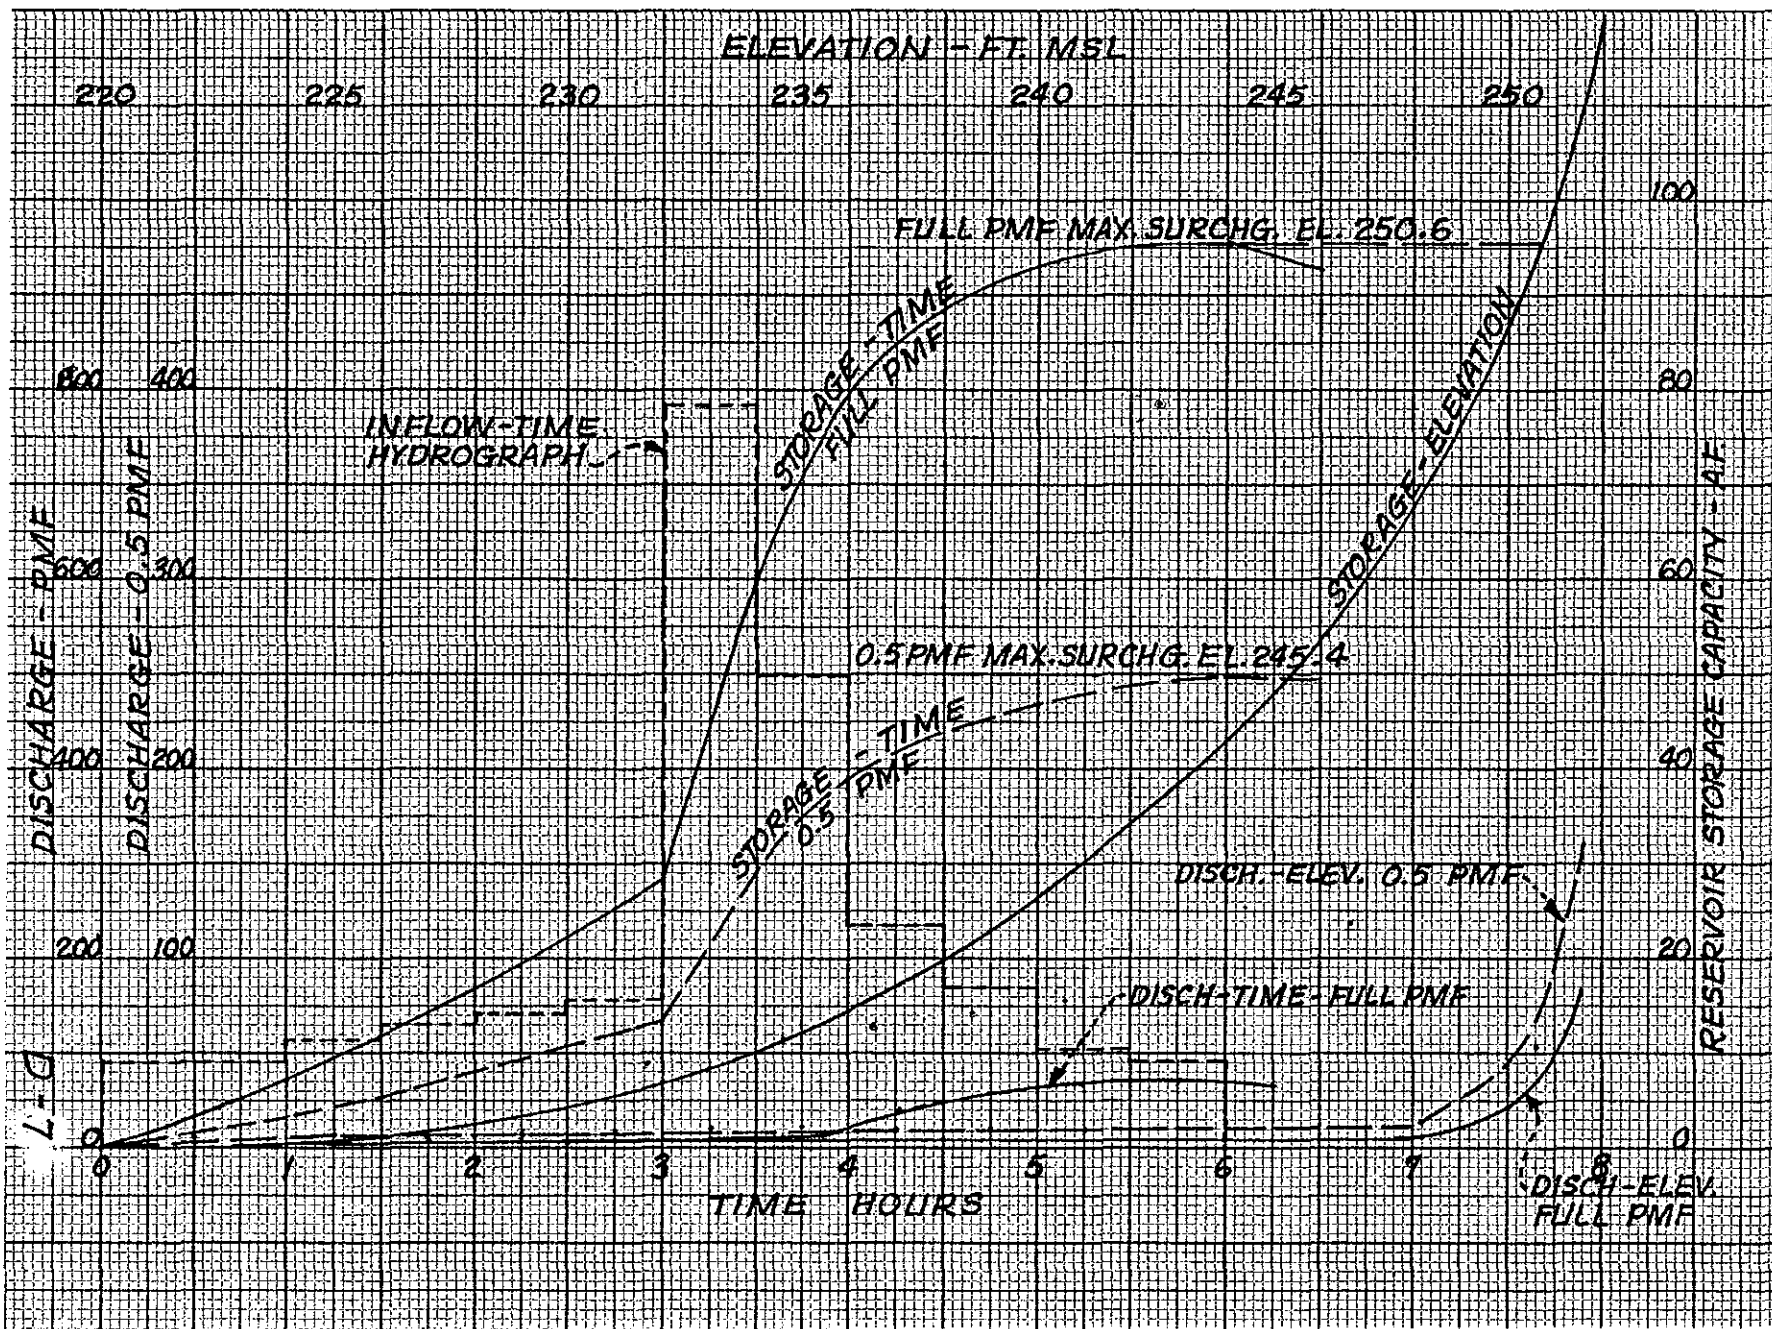
FIGURE 2
Sheet D-7

JAFFVILLE RESERVOIR NO. 2
FLOOD ROUTING FOR FULL PMF AND 0.5 PMF
RESERVOIR EMPTY AT START OF ROUTING
